West Bay at Jonathan's Landing COA
Jupiter, FL

Report #: 36668-1
Beginning: January 1, 2023
Expires: December 31, 2023

RESERVE STUDY
Update "With-Site-Visit"

August 15, 2022

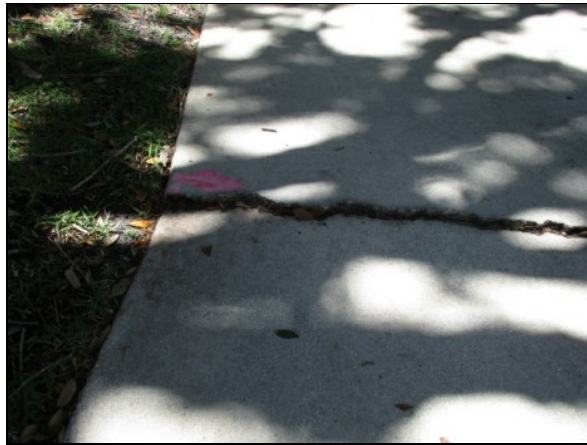
Comp #: 2105 Driveway/Sidewalk Concrete - Repair**Quantity: Approx 93,000 GSF**

Lower allowance to repair

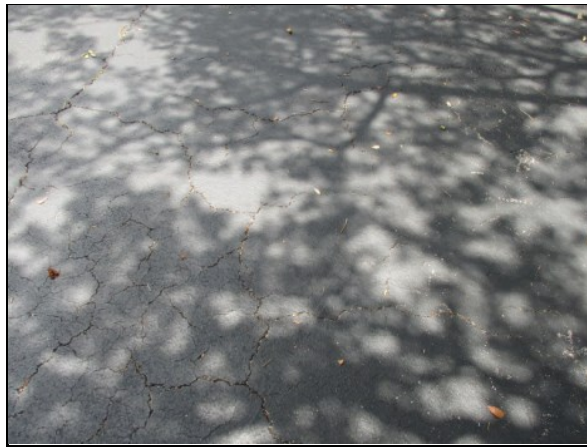
Lower estimate to seal/repair
