West Bay at Jonathan's Landing COA
Jupiter, FL

Report #: 36668-4
Beginning: January 1, 2026
Expires: December 31, 2026

RESERVE STUDY
Update "With-Site-Visit"

October 29, 2025

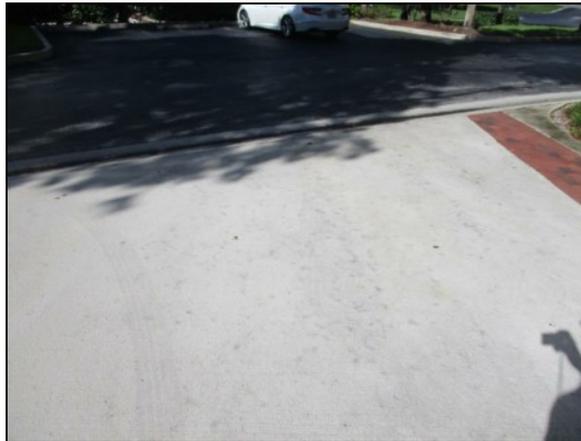
Comp #: 2105 Driveway/Sidewalk Concrete - Repair

Remaining Life:

1 years
