West Bay at Jonathan's Landing COA
Jupiter, FL

Report #: 36668-1
Beginning: January 1, 2023
Expires: December 31, 2023

RESERVE STUDY
Update "With-Site-Visit"

August 15, 2022

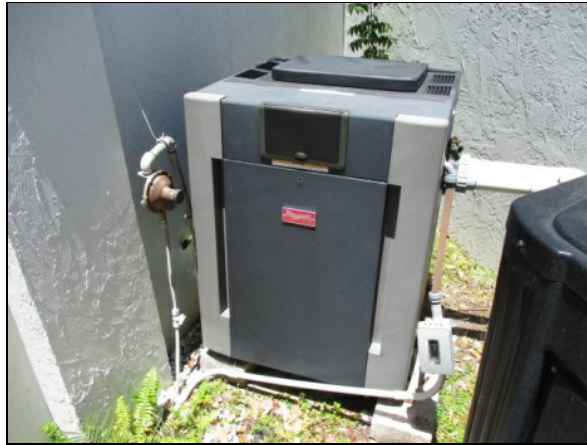
Comp #: 2781 Pool Heaters - Replace**Quantity: (2) Heaters**

Pool vendor should inspect heater regularly to ensure proper function, identify any required repairs, etc. Internal components were not analyzed during our site inspection. Many clients choose not to heat their pools year-round, which can prolong the life of the heater while reducing energy costs. When replacement models are being evaluated, we recommend considering high efficiency models which may have a higher initial cost but will ultimately be less expensive due to reduced energy usage. Minimal or no subjective/aesthetic value for pool and spa equipment. Useful life is based primarily on normal expectations for service/performance life in this location. Unless otherwise noted, remaining useful life expectancy is based primarily on original installation or last replacement/purchase date, our experience with similar systems/components, and assuming normal amount of usage and good preventive maintenance.

Lower estimate to replace

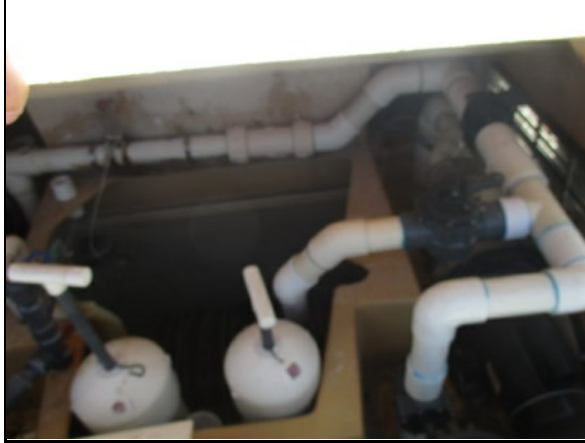
Comp #: 2787 Pool Equipment - Maintain/Replace

Comments: Pool pumps, filters, chemical feeders, and other miscellaneous equipment can be repaired or replaced for relatively low cost in most cases. However, if multiple repairs or replacements are required at the same time, then it may be warranted to use Reserve funds for these expenses. An allowance for ongoing projects is recommended here based on our experience with other properties. Minimal or no subjective/aesthetic value for pool and spa equipment. Useful life is based primarily on normal expectations for service/performance life in this location. Unless otherwise noted, remaining useful life expectancy is based primarily on original installation or last replacement/purchase date, our experience with similar systems/components, and assuming normal amount of usage and good preventive maintenance.

Lower allowance to repair/replace equipment
