West Bay at Jonathan's Landing COA
Jupiter, FL

Report #: 36668-4
Beginning: January 1, 2026
Expires: December 31, 2026

RESERVE STUDY
Update "With-Site-Visit"

October 29, 2025

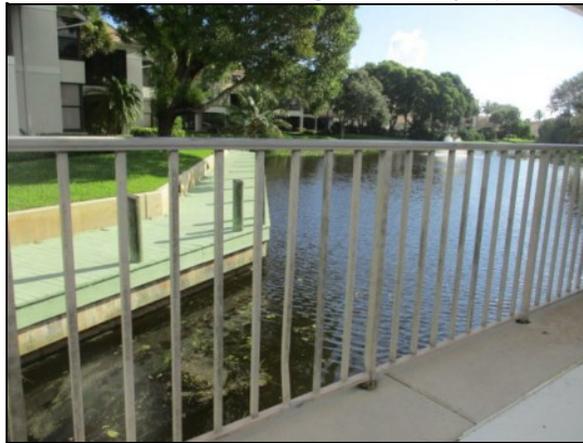
Comp #: 2771 Pool Fence - Replace

Fair condition: Pool fencing determined to be in fair condition typically exhibits some minor to moderate amounts of surface wear and other signs of age, which may include corrosion, loose or unstable pieces/sections or hardware, and/or overgrowth by surrounding vegetation. Overall, appears to be in serviceable but declining condition.

We recommend that the Client periodically clean fencing with an appropriate cleaner and touch up paint as needed in between regular paint cycles. Gates and locks should be inspected to make sure they close and lock properly as a faulty perimeter around a pool area can expose a Client to significant liability risk. As a routine maintenance item, fence should be inspected regularly and repaired as needed through the Operating budget to ensure safety. When evaluating replacements, be sure to comply with any applicable building codes. When possible, replacement should be coordinated with other projects, such as pool deck projects, other fencing/railing work, etc. Based on evident conditions, aesthetic standard considerations, and/or Client history provided during this engagement, we recommend replacement at the approximate interval shown below. Unless otherwise noted, cost estimates below assume replacement with a similar material/height as currently in place.

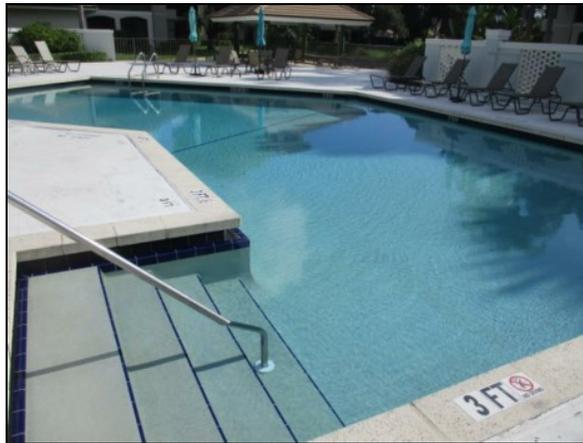
Fair condition: Swimming pools determined to be in fair condition typically exhibit some color fade/discoloration, and roughening of the surface, often more noticeable in the shallow areas and/or at steps. Waterline tiles are in fair condition. Generally believed to be aging normally.

Minor repairs and routine cleaning/maintenance should be considered an Operating expense. Pool resurfacing will restore the aesthetic quality of the pool while protecting the actual concrete shell of the pool from deterioration. This type of project is best suited for slow/offseason to minimize downtime during periods when pool is used heavily. Should be expected at the approximate interval shown below; in some cases, schedule may need to be accelerated due to improper chemical balances or aesthetic preferences of the Client. While drained for resurfacing, any other repairs to lighting, handrails, stairs, ladders, etc. should be conducted as needed.

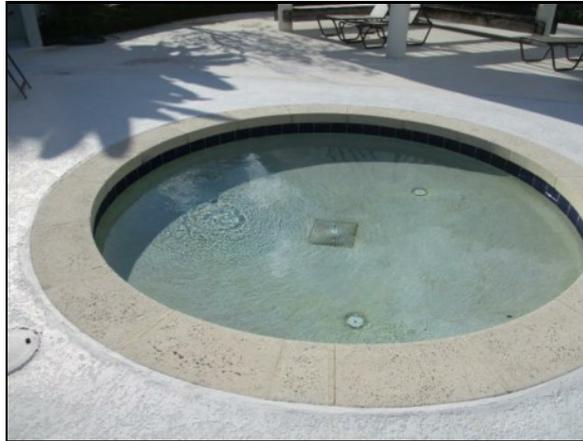
Fair condition: Spas determined to be in fair condition typically exhibit some color fade/discoloration, and roughening of the surface, often more noticeable in the shallow areas and/or at steps. Waterline tiles are in fair condition. Generally believed to be aging normally.

Minor repairs and routine cleaning/maintenance should be considered an Operating expense. Spas sometimes need to be resurfaced more frequently than pools due to higher chance of chemical imbalances. This type of project is best suited for slow/offseason to minimize downtime during periods when spa is used heavily. Whenever possible, both the pool and spa should be done at the same time to achieve better pricing and minimize downtime. While drained for resurfacing, any other repairs to lighting, handrails, stairs, ladders, etc. should be conducted as needed.

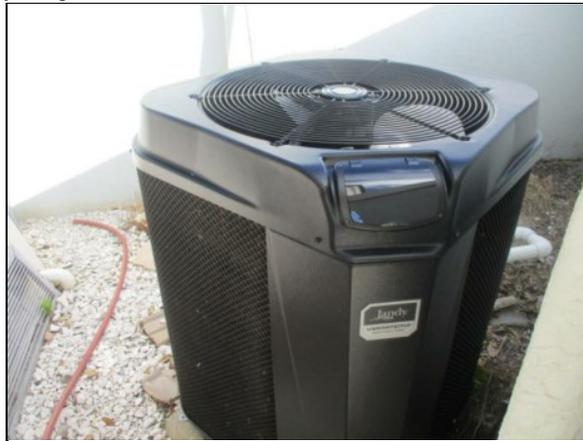
Comp #: 2781 Pool Heaters - Replace

History: Pool heaters, heat pump and propane unit, were replaced in 2022 for \$6,292 and \$4,550 (per information provided).

Pool vendor should inspect heater regularly to ensure proper function, identify any required repairs, etc. Minimal or no subjective/aesthetic value for pool and spa equipment. Internal components were not analyzed during our site inspection. Useful life is based primarily on normal expectations for service/performance life in this location. Many Clients choose not to heat their pools year-round, which can prolong the life of the heater while reducing energy costs. Unless otherwise noted, remaining useful life expectancy is based primarily on original installation or last replacement/purchase date, our experience with similar systems/components, and assuming normal amount of usage and good preventive maintenance. When replacement models are being evaluated, we recommend considering high efficiency models which may have a higher initial cost but will ultimately be less expensive due to reduced energy usage.

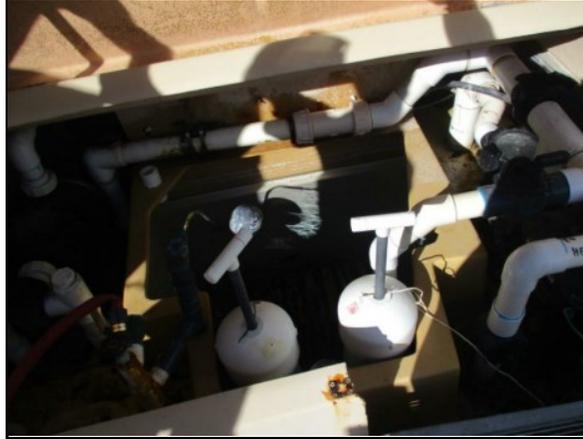
Comp #: 2787 Pool Enclosure/Equipment - Replace

Comments: *NOTE: Funding includes full replacement of both the equipment enclosure and related pool equipment.
